MINNESOTA HISTORICAL SOCIETY

THE CONSERVATION OF AN 1879 HASKELL AND BARKER WOODEN BOX CAR

By Paul S. Storch, Senior Objects Conservator
Daniels Objects Conservation Laboratory
Minnesota History Center
Minnesota Historical Society

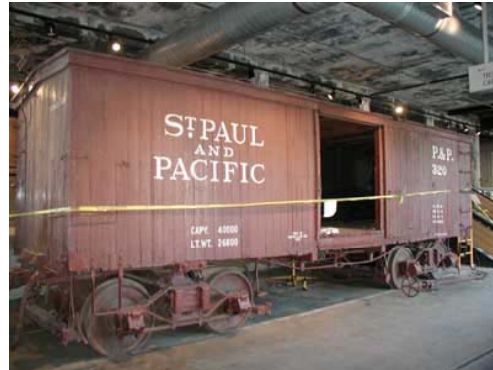
Until being placed indoors in MCM, the box car had been stored outdoors. The overall condition of the boxcar was fair when received for treatment. Most of the paint remained on the body, and on the iron trucks and wooden undercarriage parts as well. The interior was very dusty and there was debris from years of use as a storage room for

Figure 3: Proper right side view of the boxcar before treatment.

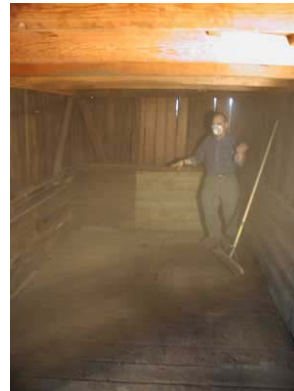
Figure 4: Cleaning of interior in progress.

The first step in the treatment was to clean the exterior with a dilute soap solution to remove grime and dust. The interior was vacuumed and cleaned with compressed air after the larger debris and parts were picked up.

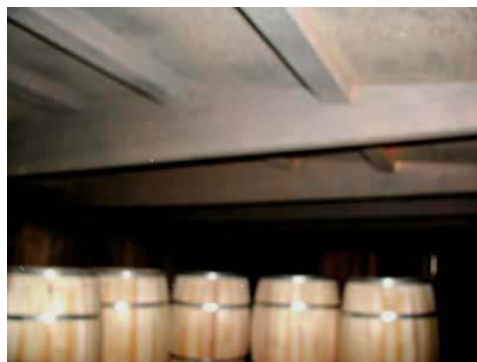
Figure 5: Interior view of the ceiling.

Once the interior was cleaned, the previously restored unpainted ceiling was toned with Liquitex acrylic dispersion paint applied with an airless sprayer. In order to show how the box car was used at the mill, empty reproduction flour barrels were acquired and are displayed inside.

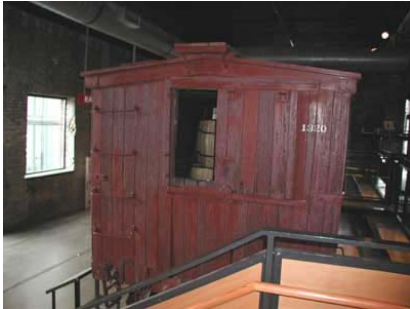
The window end of the box car sustained the worst damage to the paint on the siding boards. The paint layer was brittle and had lifted off the wood siding surfaces. The treatment consisted of consolidation of the existing paint with Rhoplex 234 acrylic emulsion adhesive solution 1:1 in deionized water. The solution was brushed under the lifting paint and allowed to set. The consolidated paint was heat-sealed to the wood with a tacking iron over silicone-release polyester film. This method was used over the extent of the siding boards where there was lifting paint.

Figure 6: View of window end of box car after paint consolidation and in-painting.

When the paint was stabilized, the loss areas were in-painted with Liquitex acrylic dispersion paints to blend in with the existing paint color.

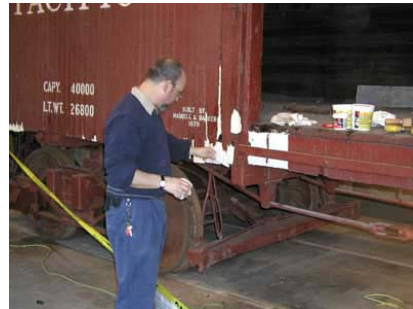
Figure 7: Wood fills being applied by the author.

acetate emulsion wood glue and clamps. Once the boards were properly positioned and mended, loss areas were in-filled with Abatron Wood Epox two-part epoxy putty and surfaced with Permafix acrylic emulsion putty. After smoothing with sand paper and a compressed air rotary grinding tool, the fills were in-painted with Liquitex acrylic dispersion paints.

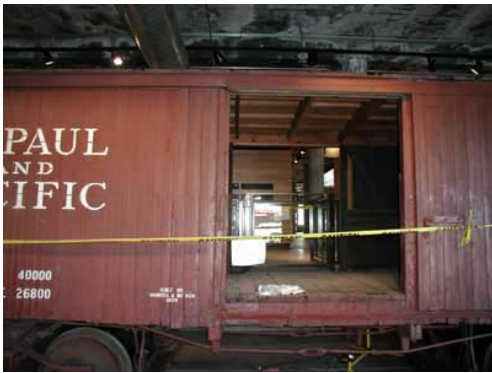
Figure 8: Proper right side of boxcar showing finished fills below door opening.

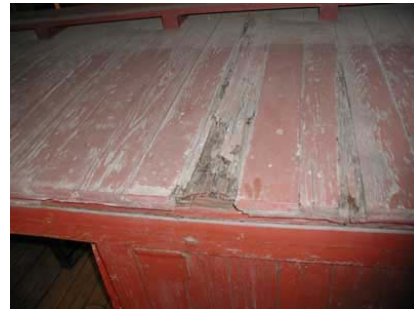
Figure 9: View of deteriorated roof boards before treatment.

The proper left front end of the roof had an approximately six foot long area of boards that had sustained severe water damage during outdoor display and were no longer structurally stable. The rotted wood was powdering and breaking off.

The deteriorated boards were removed and discarded of. The underlying plywood roof support was cleaned. Remaining parts of the outer boards were consolidated with the Abatron Liquid wood epoxy.

New pine flooring boards were purchased and cut to fit the loss areas. The new boards were attached to the roof with screws. The new boards were toned with Liquitex acrylic dispersion paints to blend in with the existing roof color.

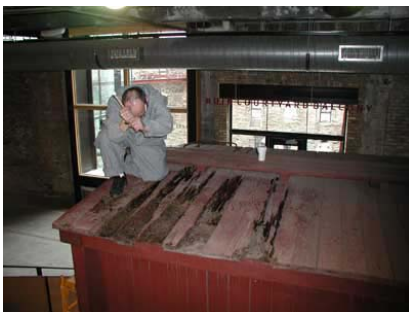
Figure 10: Detail of roof board stabilization in progress. The darker areas show where the liquid epoxy was used.

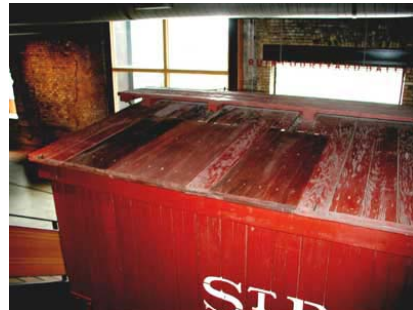
Figure 11: Overview of roof repairs.

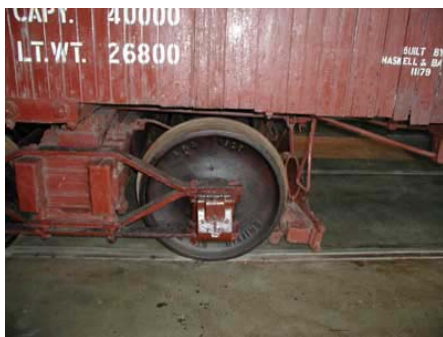
Figure 14: Tannic acid/resin treatment in progress on inner surfaces of wheels.

The metal surfaces were cleaned with compressed air needle scaling tools and rotary steel brushes. The heavy corrosion products were removed down to a more even oxidized surface. The metal surfaces were then brush coated with Rust-X corrosion stabilizer. The formulation consists of tannic acid and a water-based ethylene vinyl acetate (EVAc) resin and can be used on painted surfaces as well as on raw metal. The tannic acid reacts with the corrosion products and forms a stable surface. The EVAc resin forms a durable coating over the surface, obviating the need for further coating.

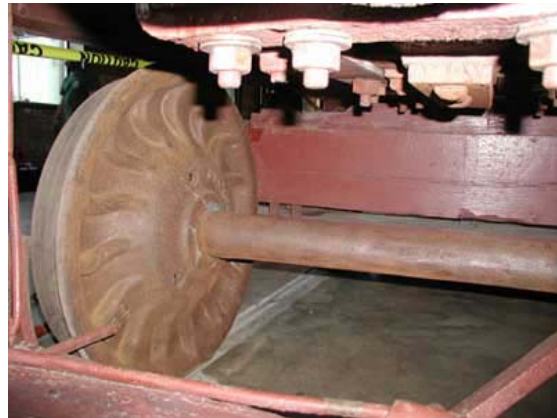
The trucks and undercarriage were in stable condition overall; however, there were areas of deteriorated paint and corrosion products on the metal surfaces.

Figure 13: Before treatment view of the inside of a wheel and axle.

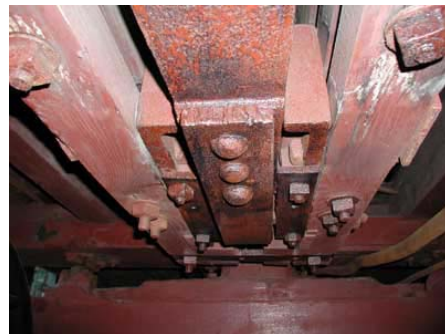
Figure 15: Tannic acid/resin treatment results on metal components with paint remnants.

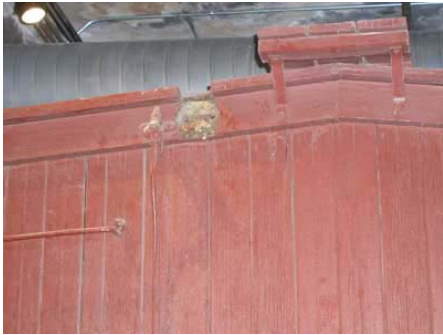
Figure 16: Before treatment view showing brake mechanism attachment area.

The exterior brake adjustment mechanism was removed prior to moving the box car to the MCM. The mechanism was cleaned and waxed before reattachment in the original position.

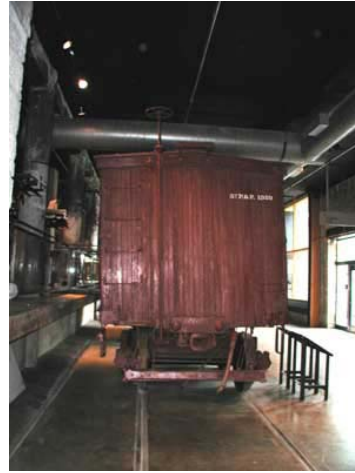
Figure 17: View of the brake mechanism in place.
