MINNESOTA HISTORICAL SOCIETY

THE CONSERVATION OF TWO CAST IRON BELLS AT THE LAC QUI PARLE MISSION HISTORIC SITE

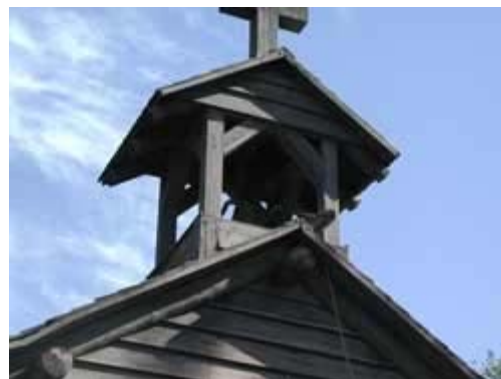
Figure 1: Front view of bell tower on Lac Qui Parle reconstructed mission building.

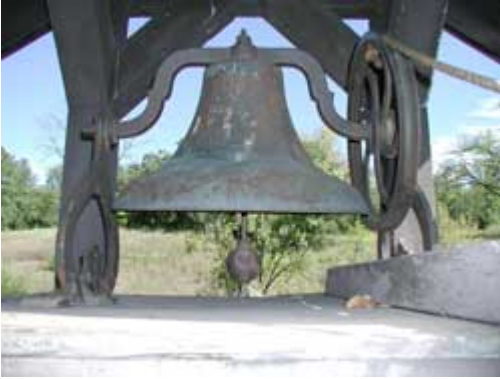
Figure 2: Front view of exterior bell before treatment.

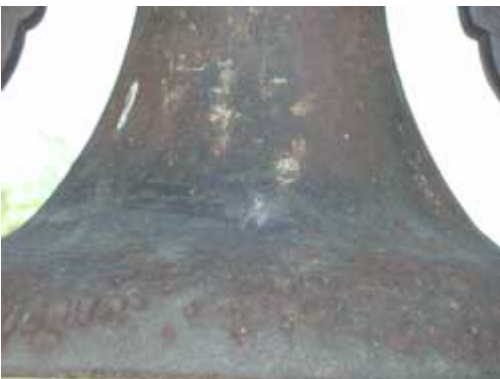
Figure 4: Detail of exterior bell surface before treatment showing corrosion, weather metal, and organic deposits.

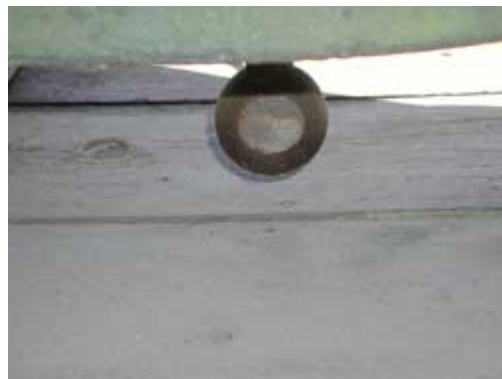
Figure 5: Detail of exterior bell clapper prior to treatment showing the wear surfaces from ringing by visitors.

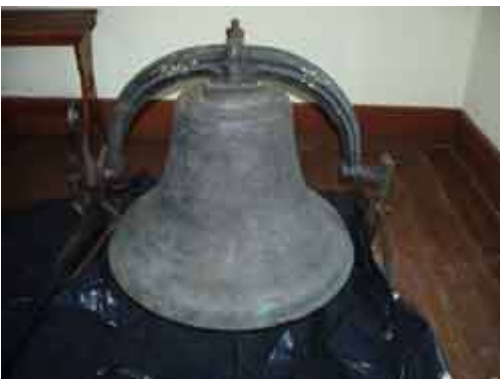
Figure 10: Interior bell showing before treatment condition paint drips on yoke, corrosion, and green paint transfer on lower bell margin. The bell was dusty overall.

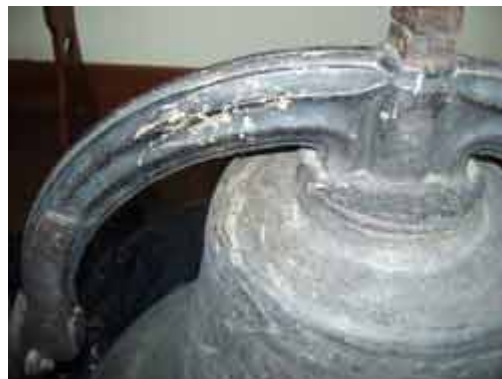
Figure 11: Detail of the yoke of the interior bell before treatment showing paint drips.

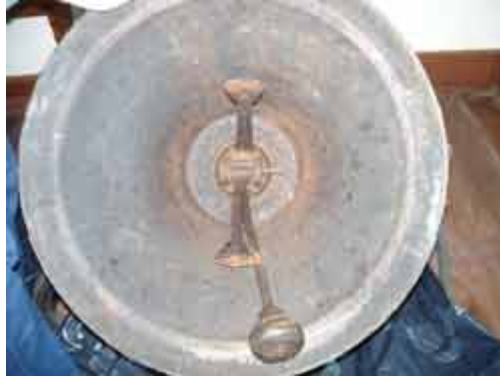
Figure 12: Interior bell before treatment showing detail of corrosion on clapper assembly and interior surfaces.

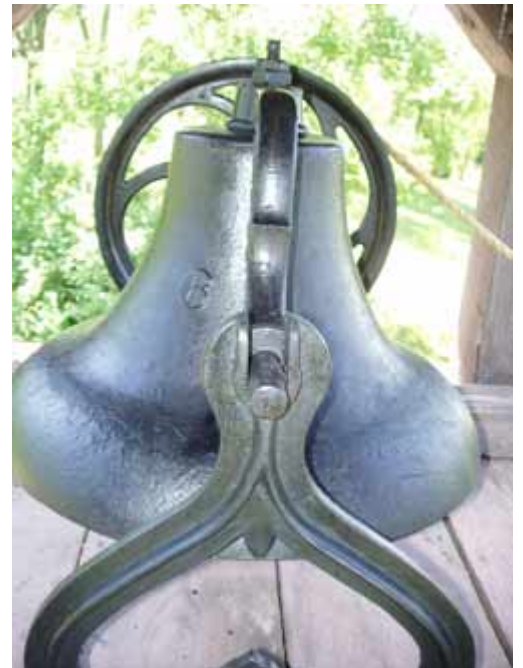
Figure 6: Exterior bell after treatment showing stabilized and restored surface.

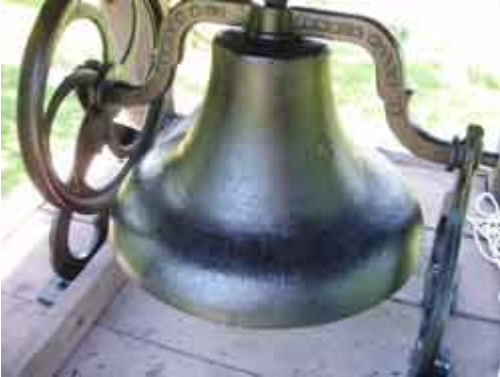
Figure 7: Exterior bell after treatment showing rear surfaces.
