MINNESOTA HISTORICAL SOCIETY

CONSERVATION TREATMENT OF THE USS WARD FORWARD GUN, MINNESOTA STATE CAPITOL MALL

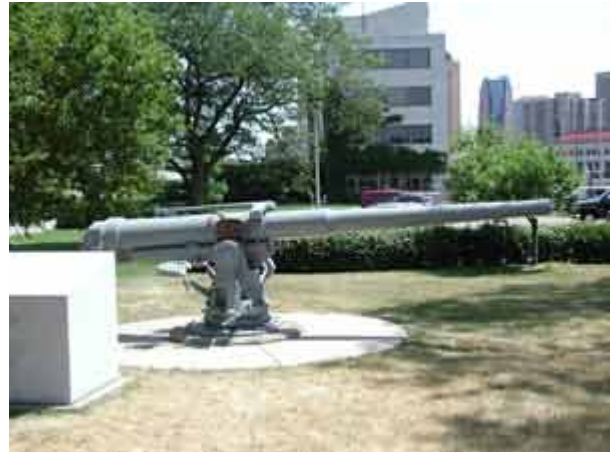
Figure 3. The PR side of the gun after treatment.

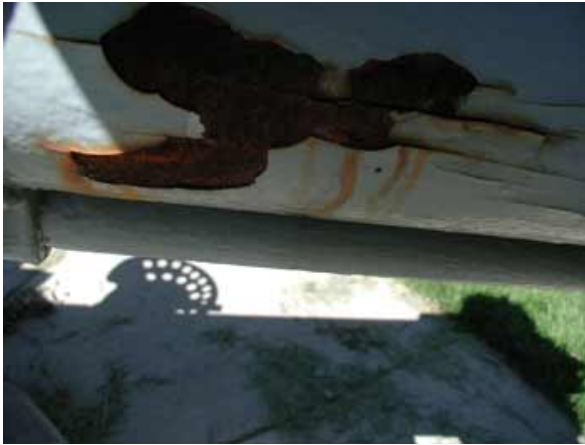
Figure 2. Failed paint and rusting on underside of the barrel.

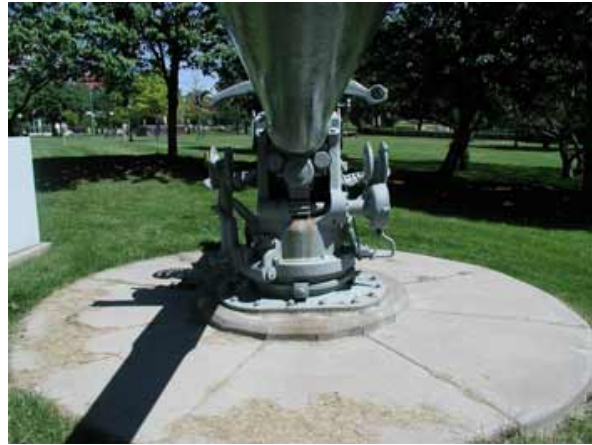
Figure 4. The front underside area of the gun before treatment. Note the rust stains near the bolts on the concrete support base.

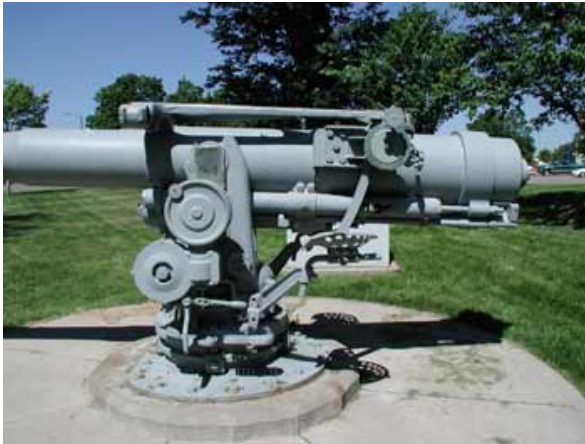
Figure 5. The PL side of the gun before treatment. Note the corrosion on the nickel plated dedication plaque.

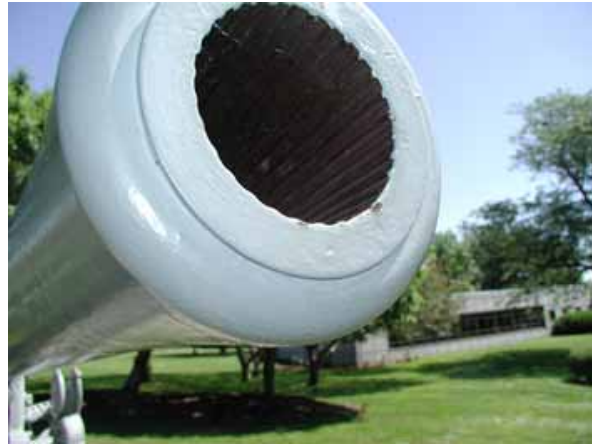
Figure 7. The muzzle before treatment showing minor paint loss and corrosion on the exposed metal surfaces.

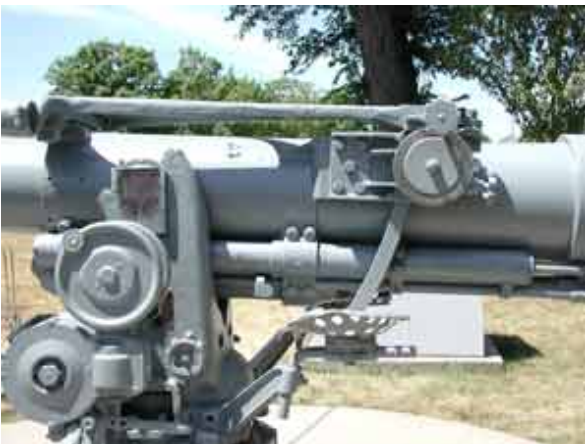
Figure 6. The PL side of the gun after treatment. Note the dedication plaque after cleaning and stabilization and the elevation gauge.

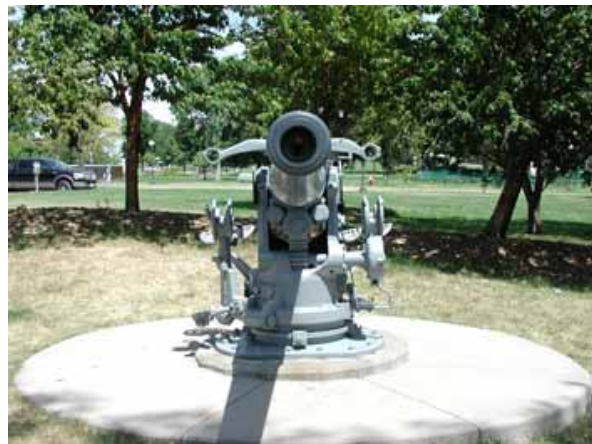
Figure 8. The muzzle end of the gun after treatment showing the modified pipe plug. The plug is removable and will prevent water intrusion and trash accumulation.

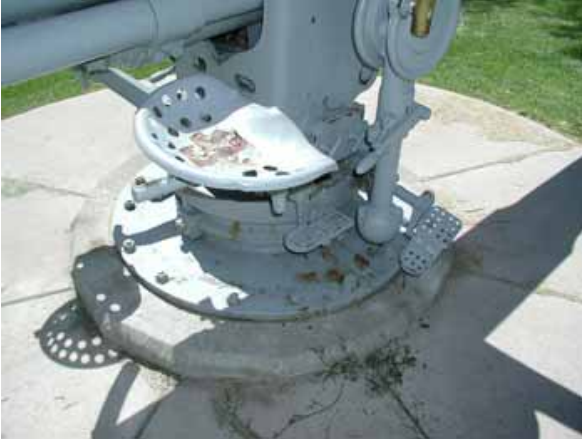
Figure 9. The PR fire control operator's seat before treatment showing paint and metal losses.

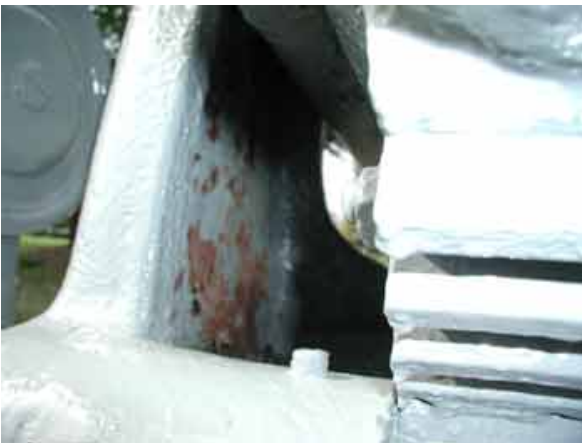
Figure 11. Underside of the swivel mount showing paint loss and corrosion.

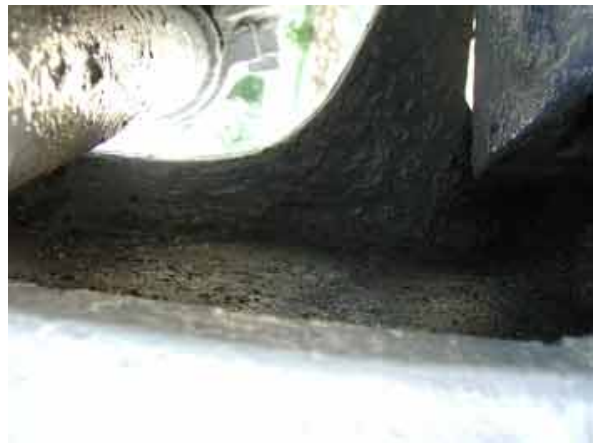
Figure 12. Underside of the swivel mount showing rust stabilizer application.

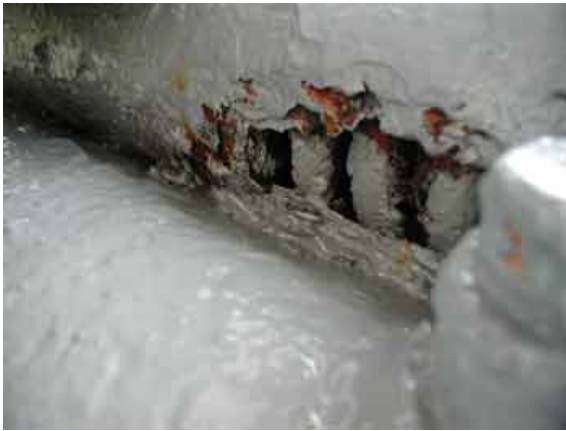
Figure 13. PR side recoil tube springs exposed due to loss from corrosion.

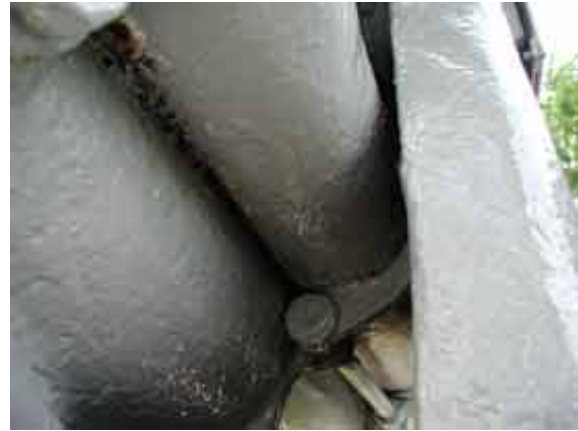
Figure 15. PL underside of recoil tubes; before treatment.

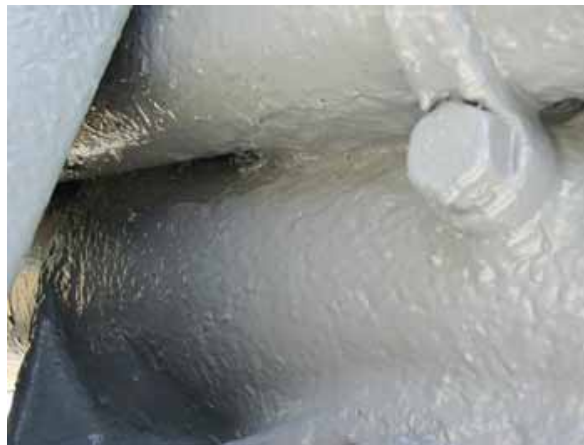
Figure 14. PR recoil tube area after epoxy fills and paint.

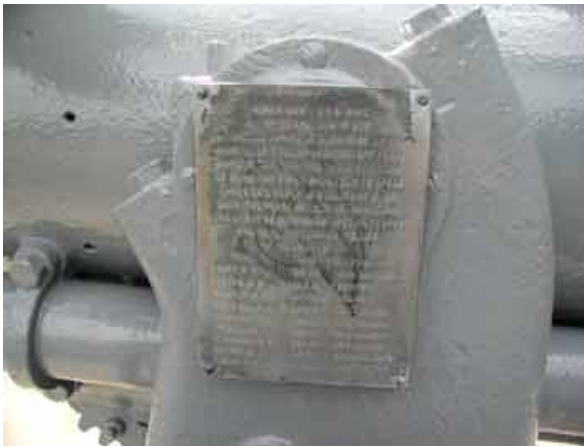
Figure 20. The PL side nickel-plated dedication plaque showing corrosion and scratches.

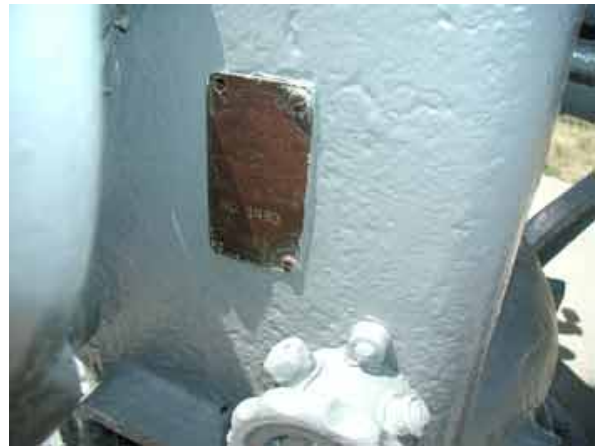
Figure 22. The manufacturer's tag on the PL swivel mount during treatment showing left side screws missing.

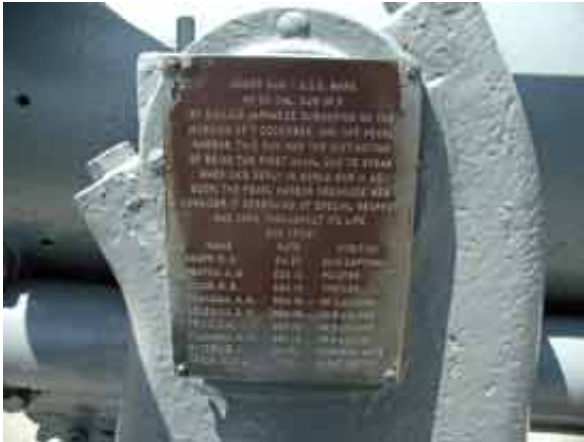
Figure 21. The PL side nickel-plated dedication plaque after cleaning and clear coating with a corrosion.

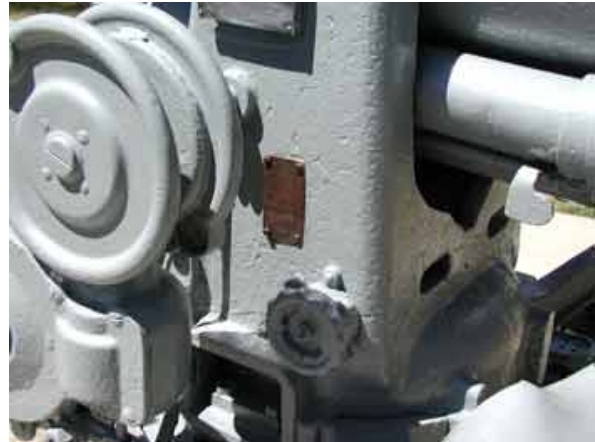
Figure 23. The PL side tag after treatment showing replacement screws.

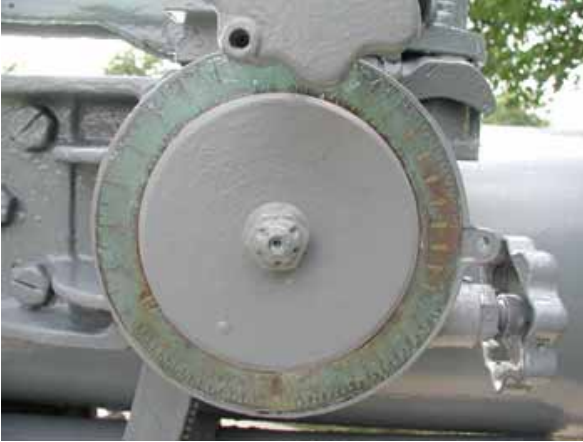
Figure 16. PL side rear of the gun showing the brass elevation gauge. The gauge had copper alloy corrosion on the surface and spots of over-paint.

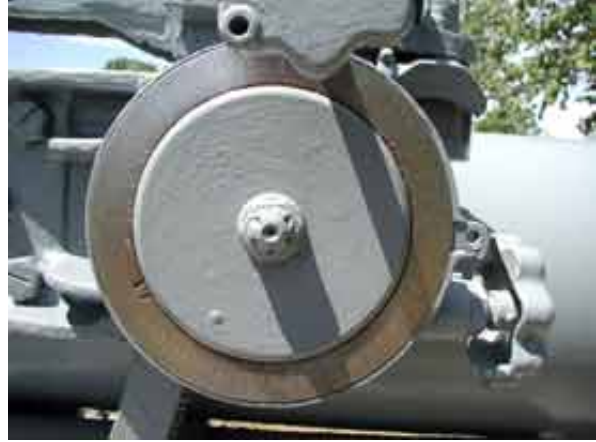
Figure 17. The gauge after cleaning and clear coating with a corrosion-inhibited acrylic lacquer.

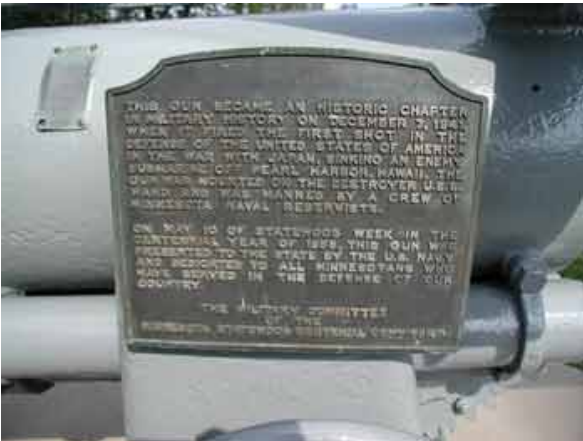
Figure 18. The PR side 1958 bronze dedication plaque before treatment showing staining and corrosion accumulation.

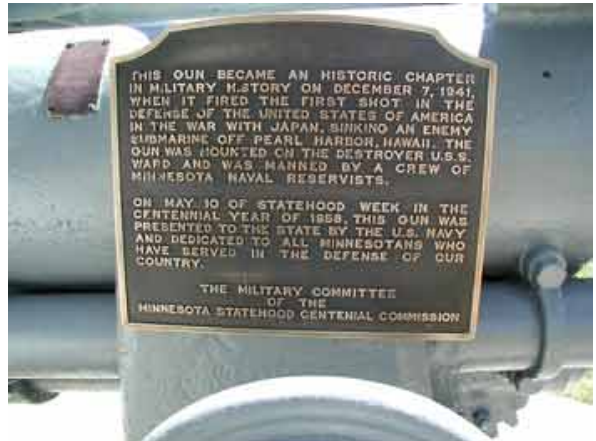
Figure 19. The 1958 bronze dedication plaque after cleaning to remove corrosion and clear coating with a corrosion-inhibited acrylic lacquer.
