TECH TALK Minnesota's Architecture • Part II

POST-CIVIL WAR ARCHITECTURE

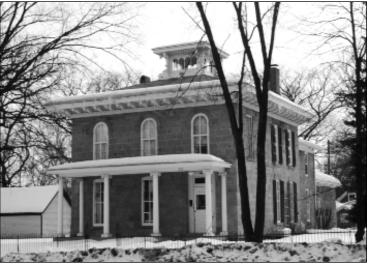
Figure 1, right above: the Thorne-Lowell house in the W. 2nd St. Historic District in Hastings was built in 1861.

The villa as an architectural style was introduced to the masses in Andrew Jackson Downing's popular work, *Country Houses**, along with Gothic-inspired country houses and cottages. (See Figure 1.) It was loosely inspired by the romantic image of Italian country villas, which are usually found in a natural setting. Its

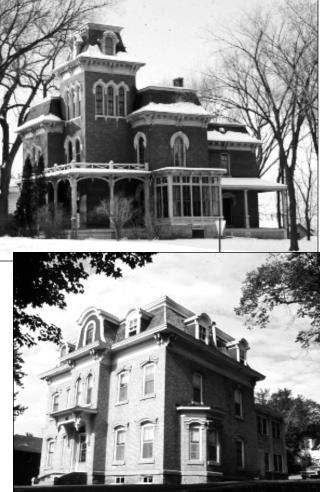
Figure 3, the Lorenz and Lugerde Ginthner house in Wabasha, listed on the National Register of Historic Places, was built in 1882.

Figure 5, right below. The Van Dyke-Libby house in Hastings was built in 1867, and is listed on the National Register of Historic Places. employ ornamental details such as brackets and columns in pairs. Low-hipped roofs with broad eaves emphasized the massing of the building below. With the exception of the cupola or tower, the Italianate Style incorporates the same ornamental characteristics as the Villa Style, though in greater abundance. (See Figure 3.)

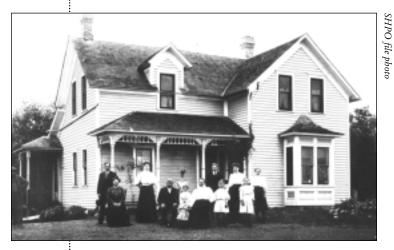
Figure 6. The Peter Roggurbush family house, Lac Qui Parle County, ca. 1895. Minnesota. It is often considered the predecessor of the American Four-Square or Corn Belt Cube of the early 20th century. The structure often began as a subsistence dwelling. As the owner prospered, a more impressive story-and-a-half addition would be constructed at right angles to the initial structure, resulting in the characteristic "L" or "T" shape. The addition often contained bedrooms on the second floor and a parlor/sitting room on the first floor. (See Figure 6.) The original structure was adapted to serve as kitchen and dining space. In many early examples of this building type, the difference in the construction of the two elements is reflected in a slight difference of materials and craftsmanship. (For example, the original section may be constructed of logs while the addition is constructed of dimension timber.) In later years, it was common to construct the entire structure at one time, although the proportions remained essentially the same as earlier examples.
